## **SEVERE FLASH FLOODS IN SLOVAKIA, JULY 2016**

**Michaela Bírová, Valéria Wendlová, Beata Randusová, Peter Smrtník**

Slovak Hydrometeorological Institute, **Slovakia**

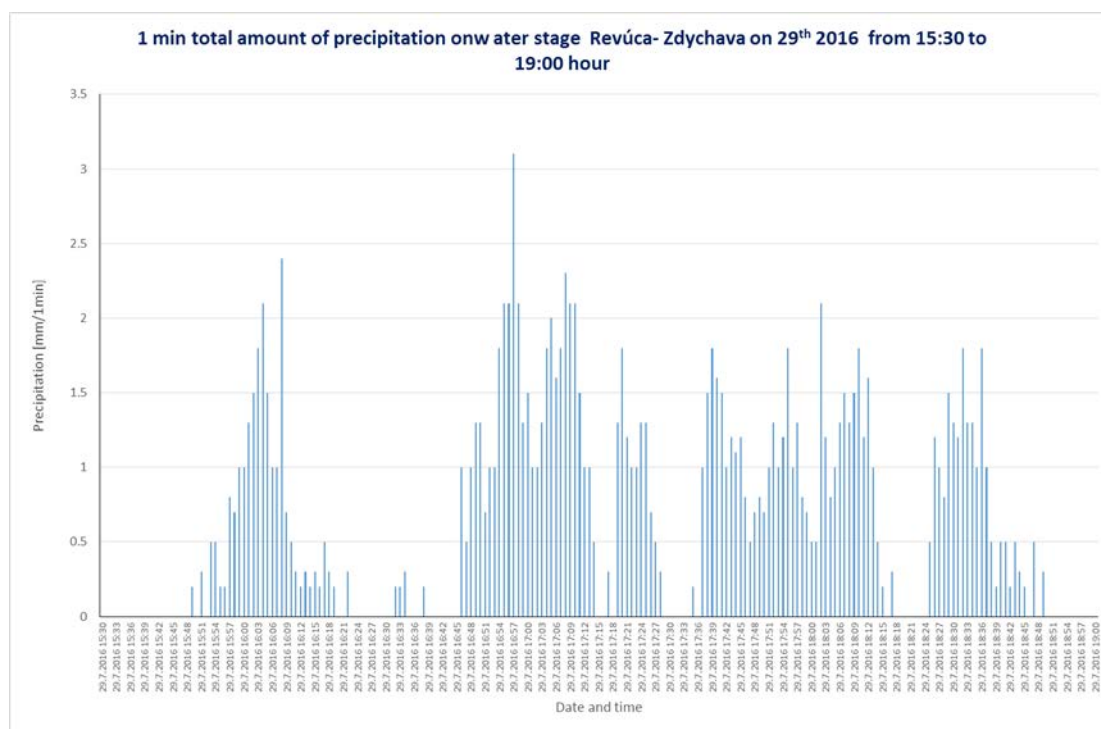
**Fig. 2:** Total amount of precipitation on July 29, 2016, Revúca-Zdychava.

As the cold front has passed along, humid air stood in the south of the middle and southeast Slovakia on Friday, July 29. Conditions for the formation of intensive storms in our territory continued, supported by the cold front passing through Poland to the east. The intense and heavy rainfall that began in Revúca on July 29 at 15:48 and ended at 18:48 CEST was preceded by a stormy activity in the north-eastern part of the Stolica Mountains and the Revúcka Vrchovina as well as in the Volovské Mountains. There are data from two rain gauging stations in Revúca. The automatic precipitation station on the northern part of Revúca measured 112 mm of rainfall in three hours. At the rain gauging station located in the city centre, near the Zdychava stream, up to 139.8 mm in three hours (141 mm/ 24 hours) were recorded. The course of the rainfall event in Revúca is in Fig. 2, showing one minute precipitation totals. This represents the highest daily total in July in this locality since 1951, and corresponds to approximately 200 to 500 annual rainfall sums.

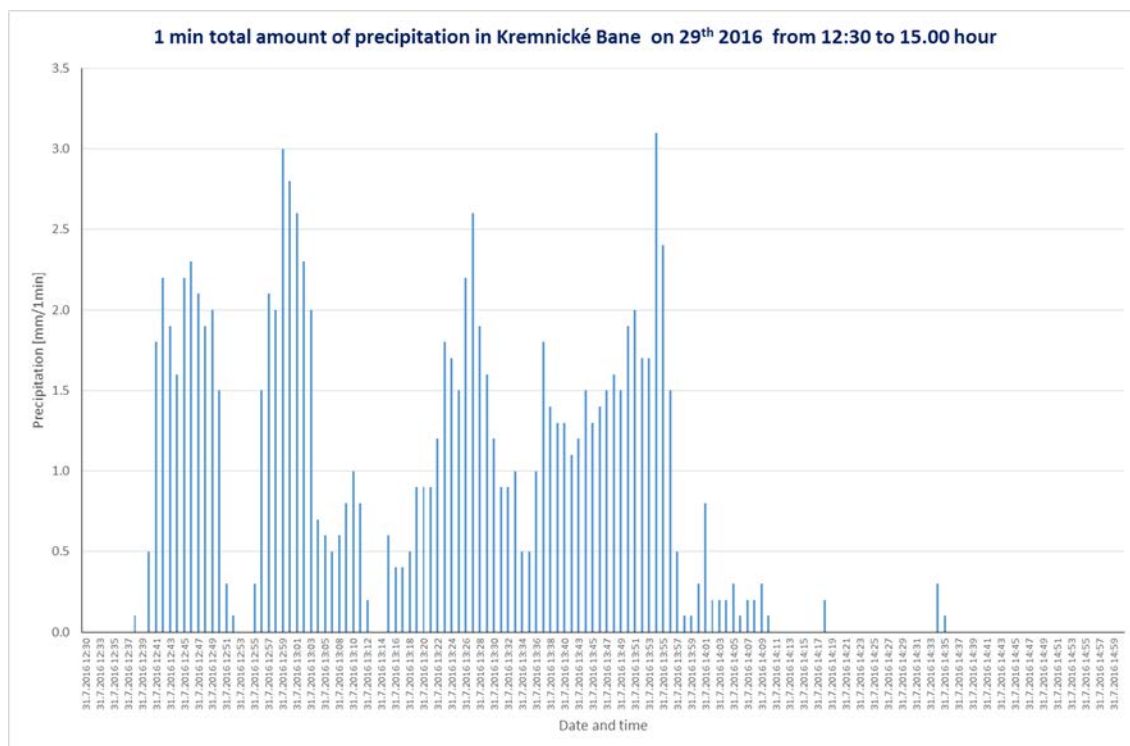
**Fig. 3:** Total amount of precipitation on July 29, 2016, Kremnické Bane.

Warm and humid air was moving thorough our territory on Sunday, July 31. On the last day of July, the cold front passed through the middle east of Europe to the east, thus creating convenient conditions for the development of intensive storms in several places. The most extreme was the stormy activity in mountains of Kremnica and also in the city of Komárno. An intense rain hit also the meteorological station in Kremnické Bane. The whole rainfall event began at 12:38 and ended at 14:44 CEST, with an

intense rainfall precipitation lasting until 13:57 (Fig.3). During this time four shorter rainfall periods occurred, during which precipitation reached the intensity of storm rainfall (> 2 mm/ min). Daily rainfall at this station reached 122 mm (72 mm per hour). Again, this is an extremely high daily precipitation, which has not occurred since 1951 in this area (Fig.4).

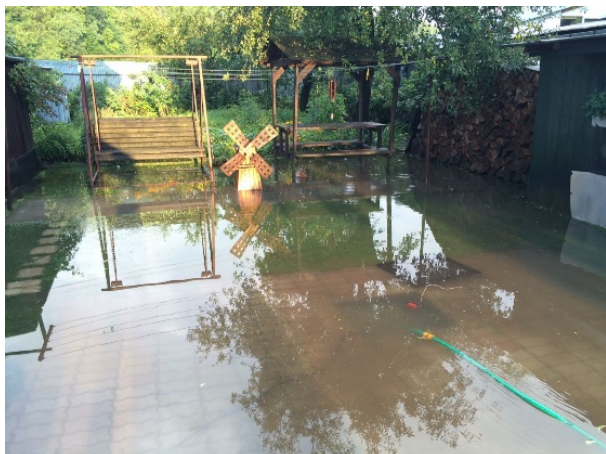
Extreme precipitations became quickly evident in the discussed localities. A report from the Emergency Response Coordination Centre (SVK ERCC) states that after the heavy storm rainfall, which hit the city of Revúca, local roads, cellars of family houses and residential homes were flooded by water and mud from the fields (Fig. 8) [1]. Based on this fact, the Mayor of the town announced 3<sup>rd</sup> degree of flood activity on July 29, 2016 at 6:30 pm. The city carried out rescue work by its own forces and resources with the help of state and voluntary firefighters. Population was warned by local radio. Water culverts and sewage drains have been clogged with flooded material during the intense rainfall and the streets have changed into water plane. Huge volumes of water flooded streets and public spaces, e.g., parking lot in front of hypermarket Tesco (Fig. 9) [1].

**Fig.8:** Flooded yard, Revúca.

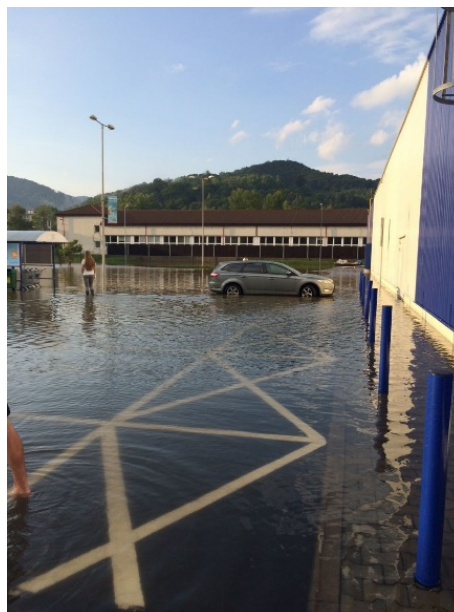
**Fig.9:** Hypermarket Tesco, Revúca.

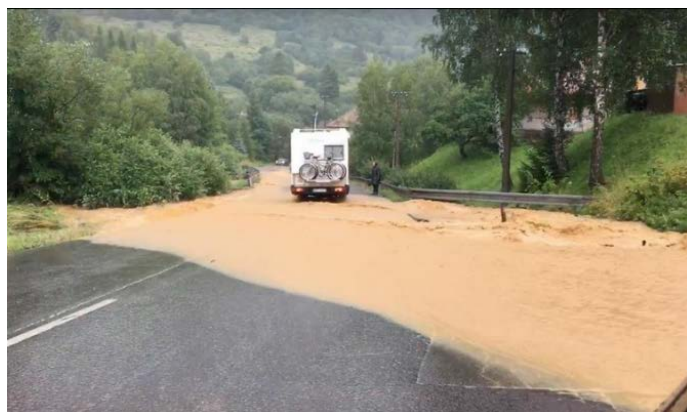
Similar reports were received also from the village of Kremnické Bane, where the Mayor of the village announced the 3<sup>rd</sup> degree of flood activity on July 31, 2016 at 3:25 pm. There was an overflow of local creek and flooding of streets because of the storm rainfall (Fig. 10, and 11). Rescue works have begun immediately by the forces and means of the municipality [2, 3].

**Fig.10:** Strong rain undermined the main road that leads through Kremnické Bane.

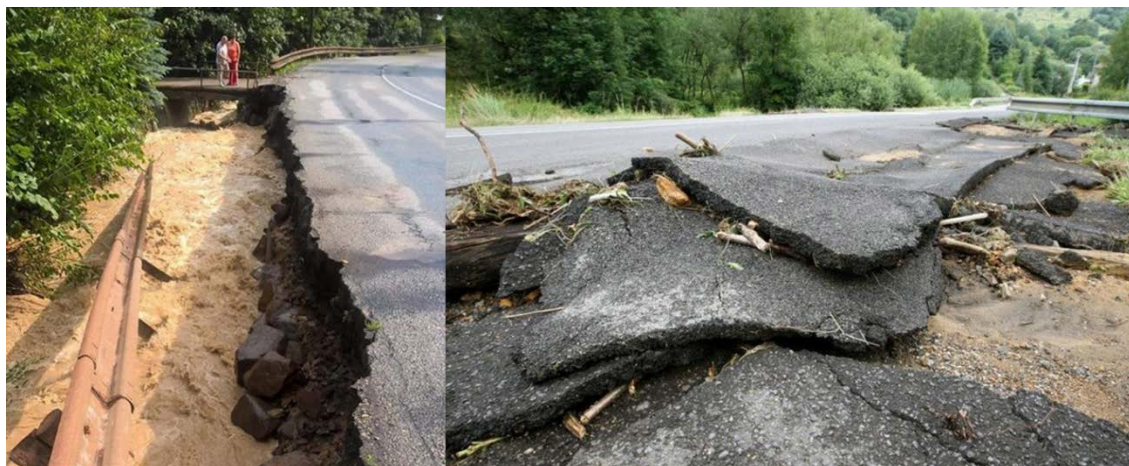
**Fig.11:** The first class road between Žiar nad Hronom and Turčianske Teplice, which runs through Kremnické Bane, was closed for several days.

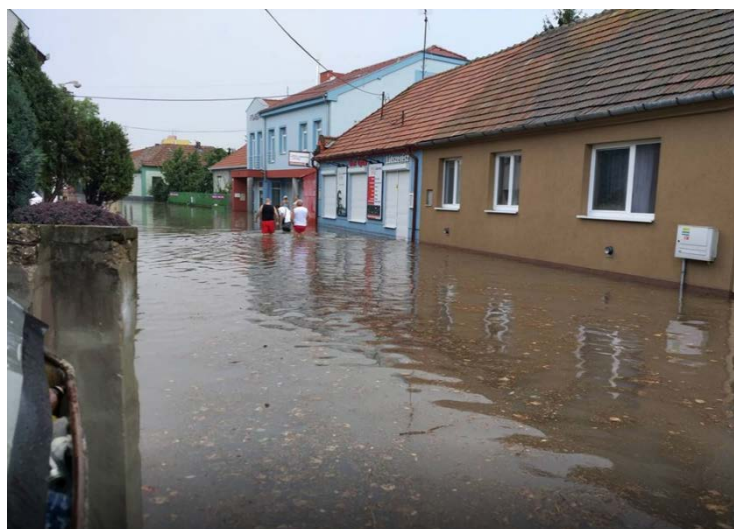
The most serious situation was in Komárno. Mayor of the city announced, together with an extraordinary situation, the 3<sup>rd</sup> degree of flood activity on July 31, 2016 at 3:35 pm. The storm rainfall caused flooding of streets, underpasses, garages, cellars, courtyards, industrial parks, and family houses (Fig. 12). There was uprooting of trees, a breakdown of the branches, which resulted in the tearing of the electricity lines and failure of the electricity supply. The units of the District Directorate of the Fire and Rescue Corps and the District Police Forces, volunteer firemen of Komárno city and volunteers were engaged.

**Fig.12:** Streets flooded in the town of Komárno.
